Memorandum

Date: *August 15, 2014*

Subject: *Oversight Summary Report
CPG Oversight of RM 10.9 Removal Action
Lower Passaic River Restoration Project*

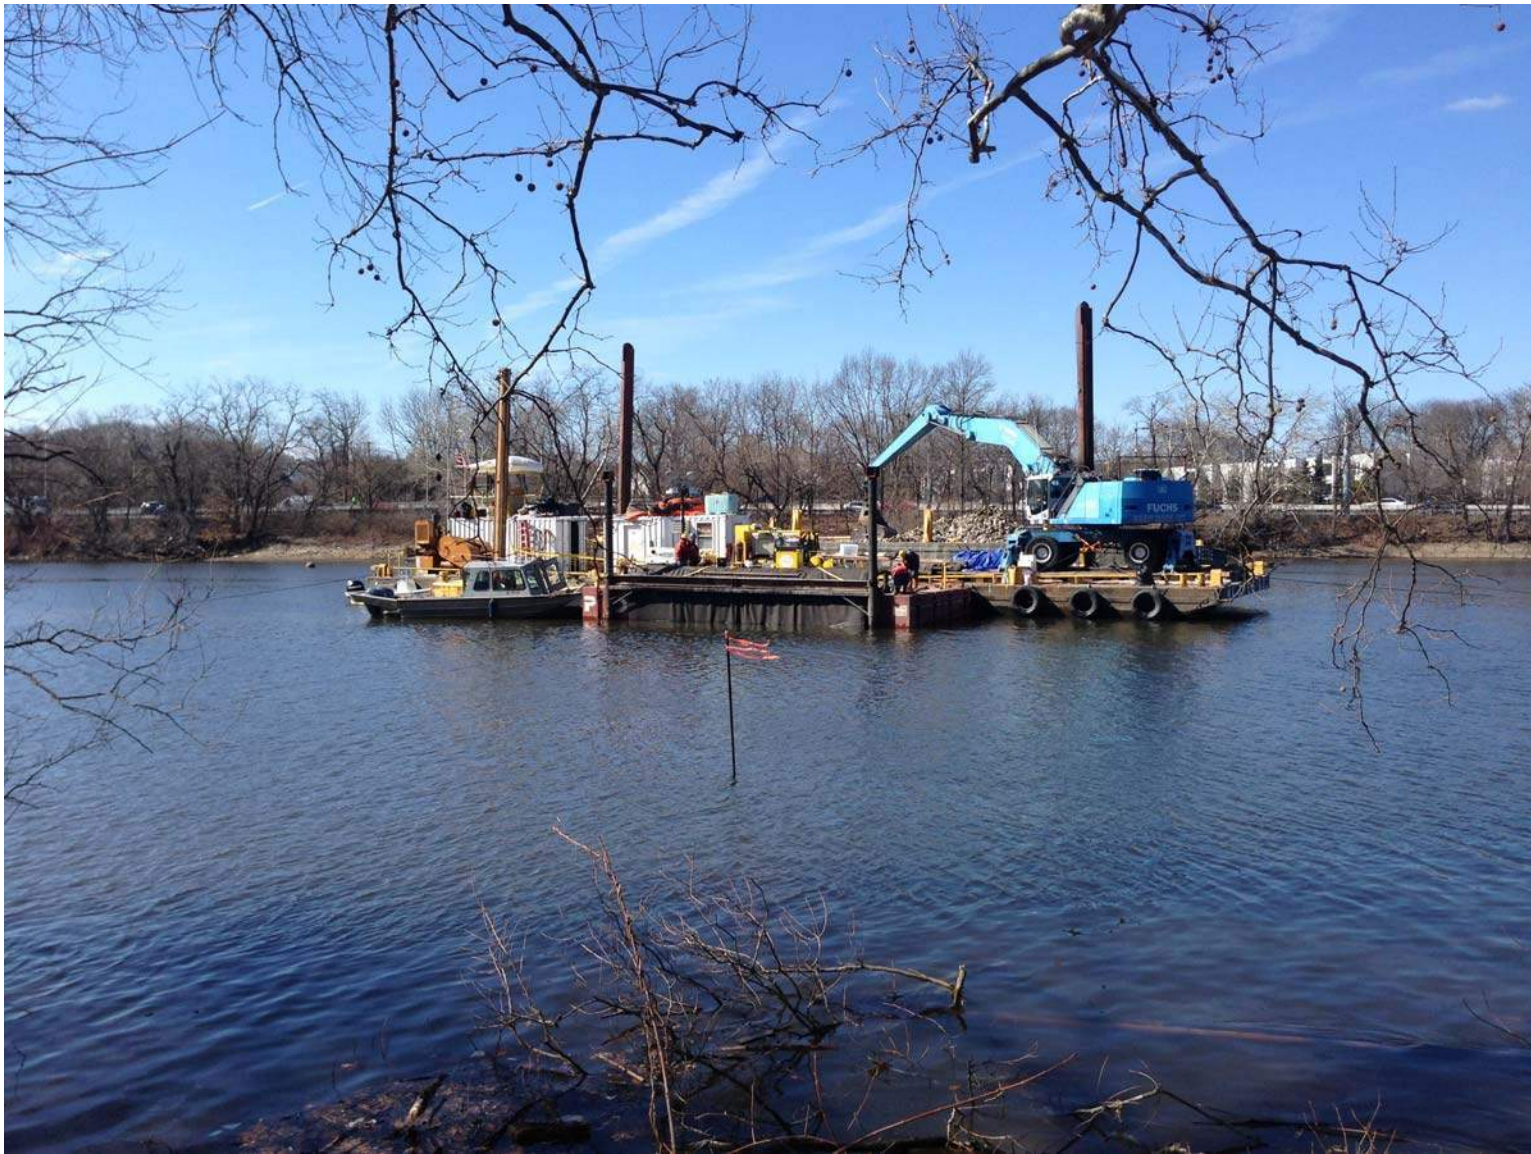
Panel 5-N Installation

Installation of geotextile panel 5-N took slightly over an hour. As shown above, the geotextile fabric was unrolled from the Poseidon barge with minimal bunching.

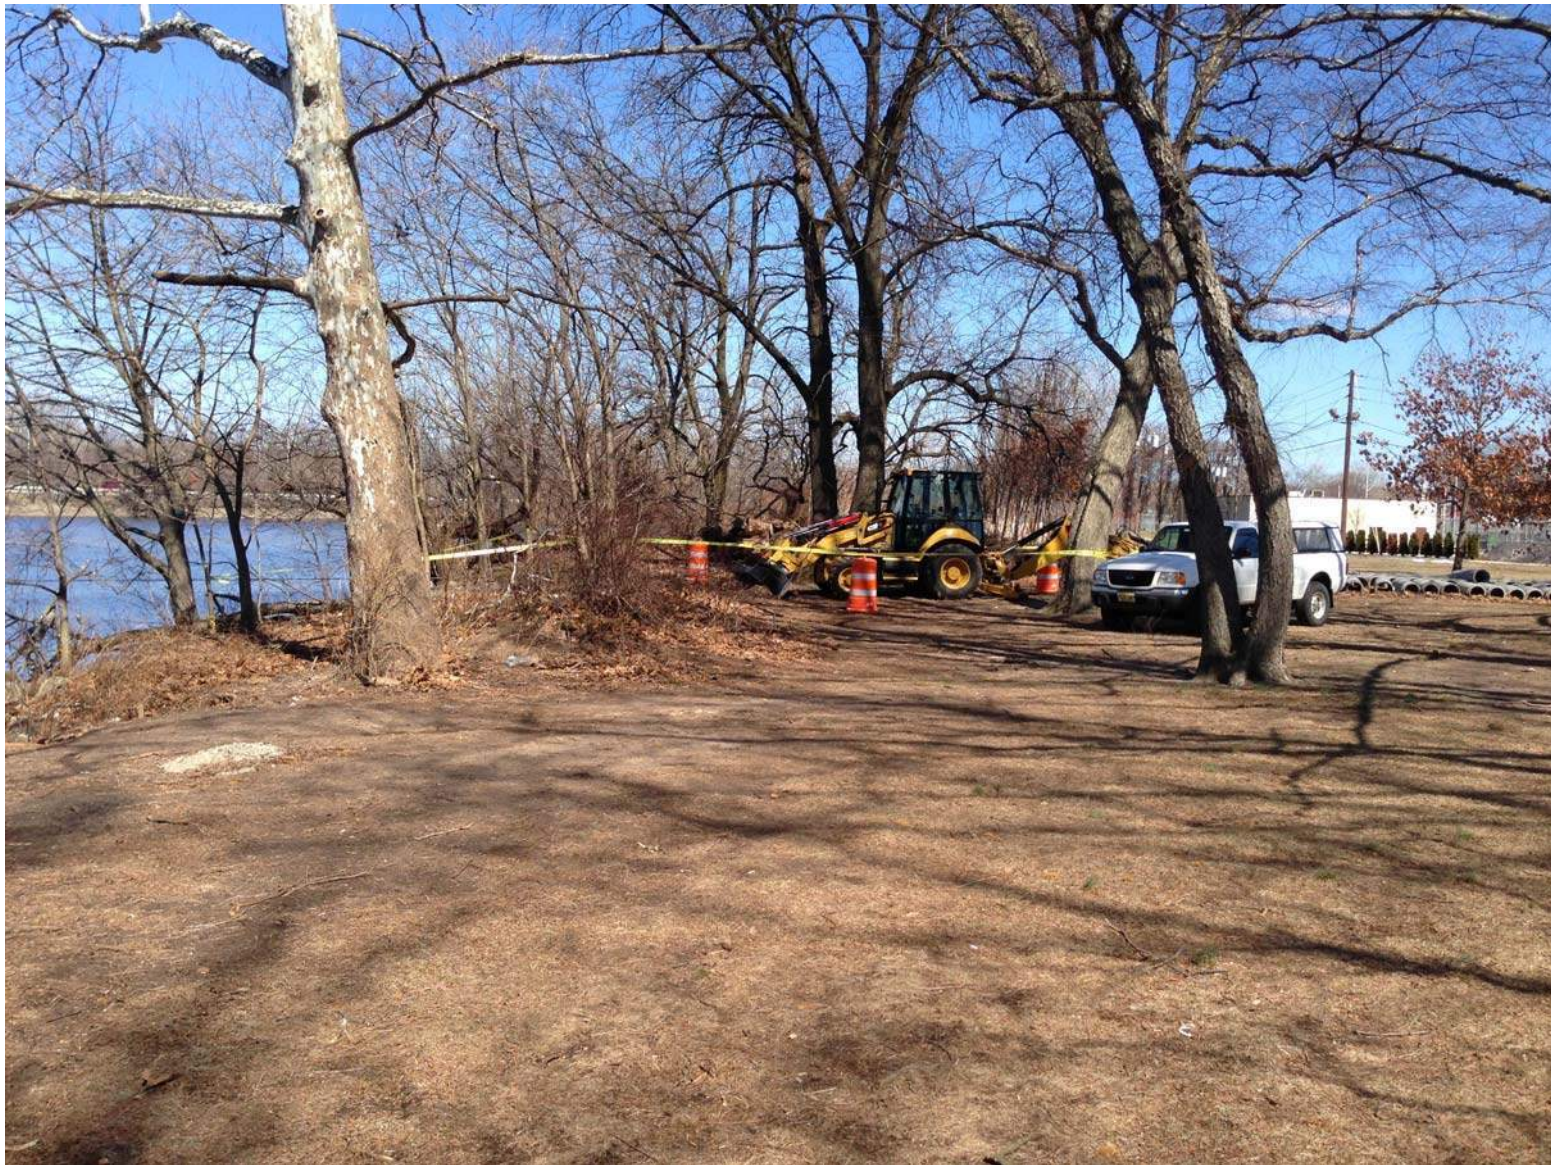
Backhoe Anchor

Prior to installing Panel 5-N, GLDD relocated the northern winch anchor (a CAT 420F backhoe) to the south.

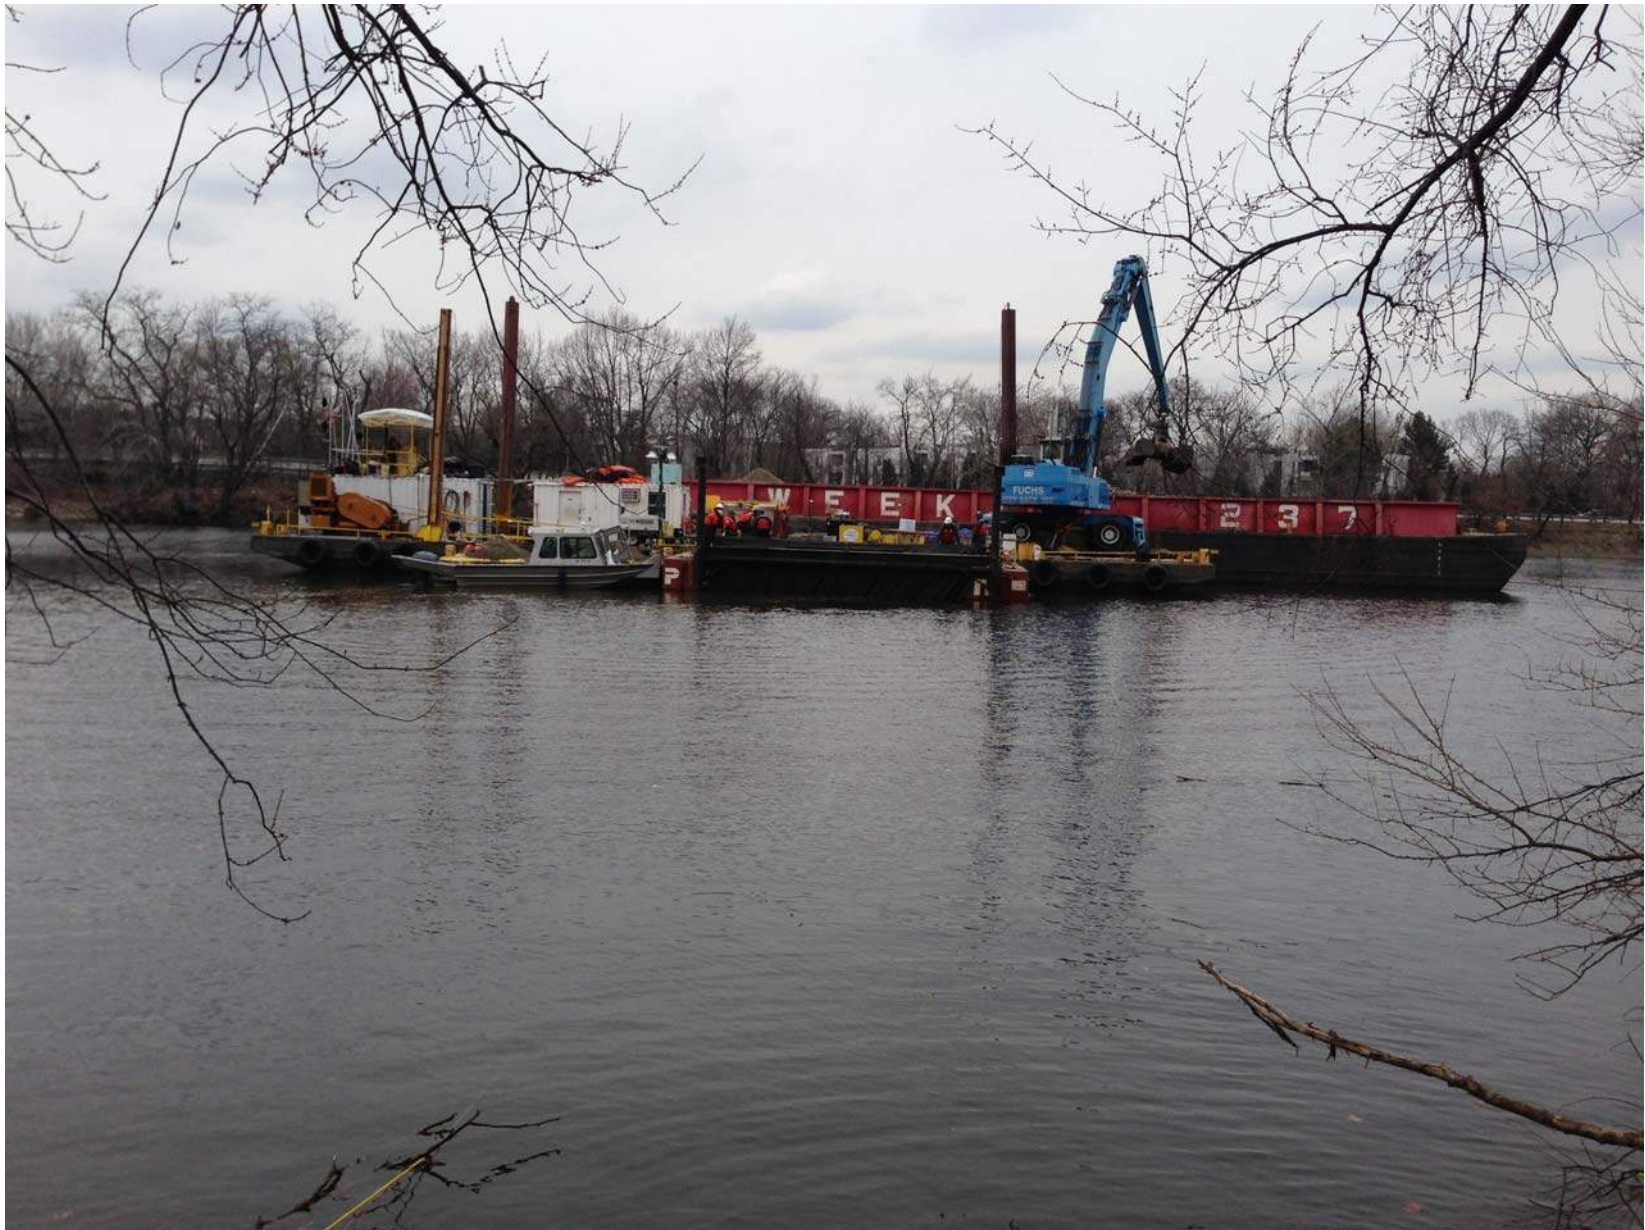
Panel 4-N Installation

Geotextile panel 4-N is approximately 150 feet long and installation took slightly over an hour.

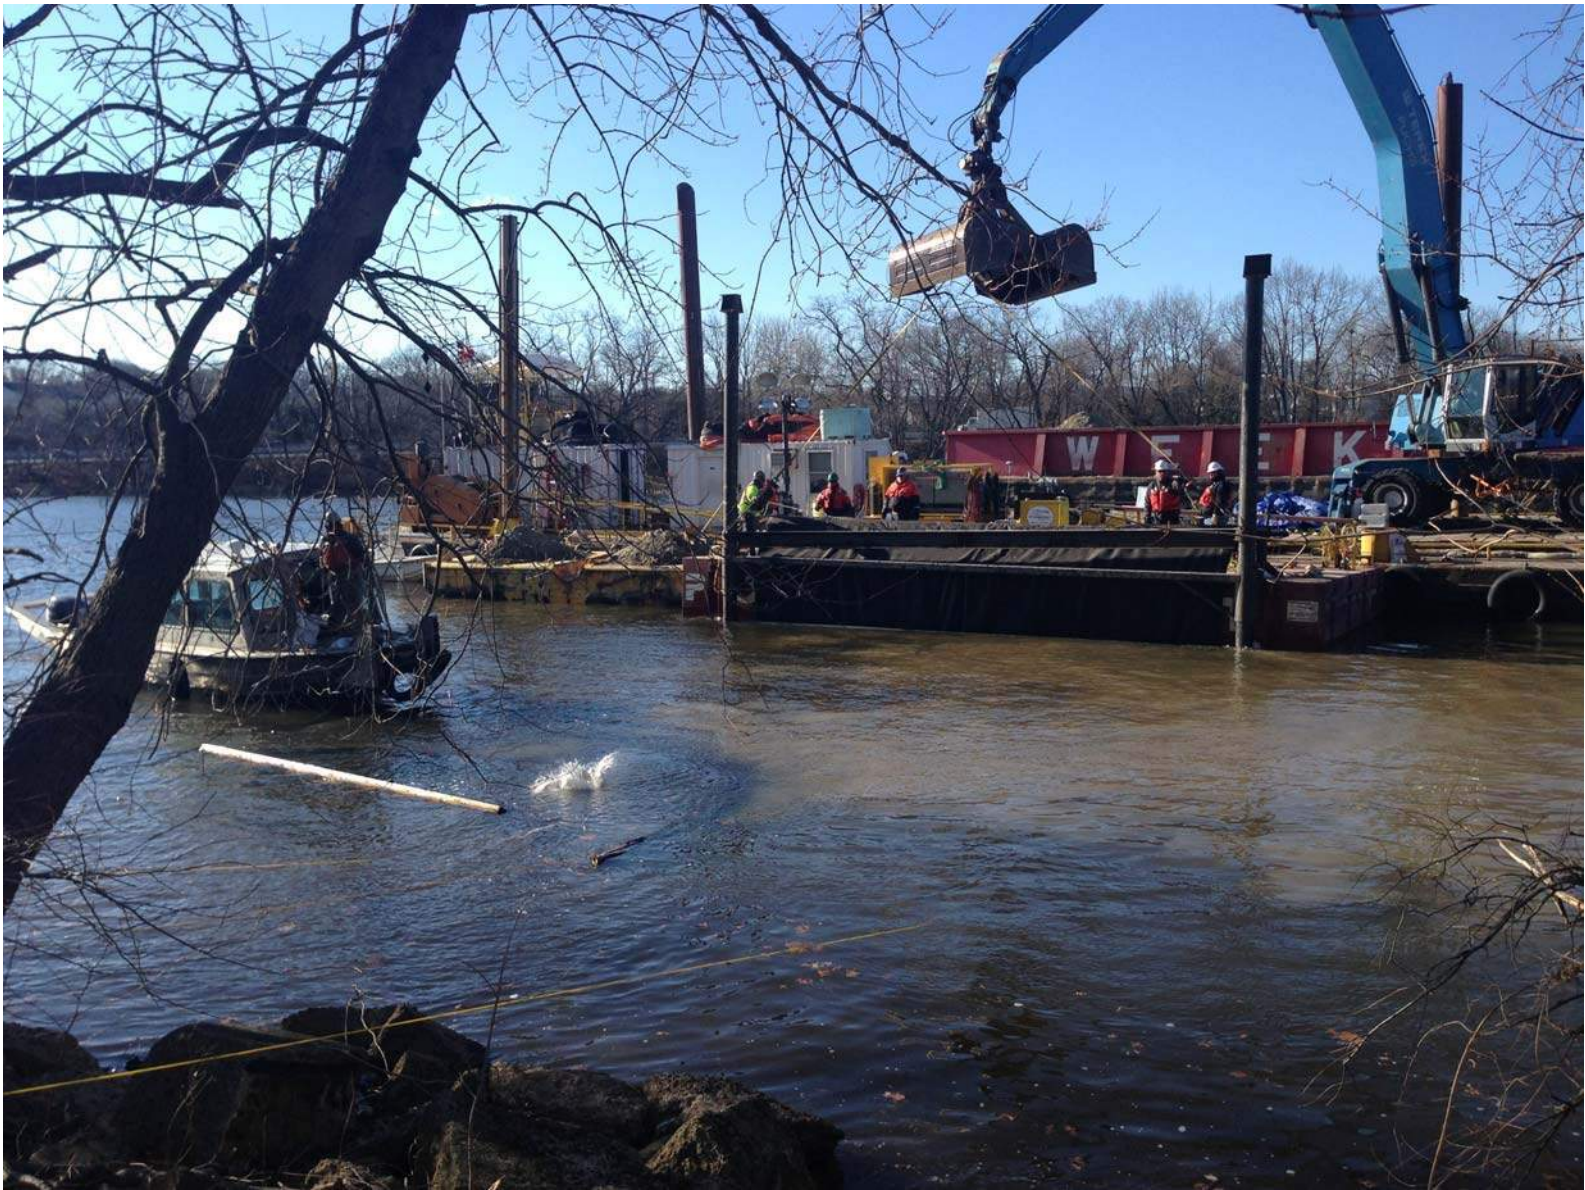
Panel 3-N Installation

Geotextile panel 3-N was installed successfully despite severe wind. Approximately 2-3 feet of overlap was observed between Panels 3-N and 4-N.

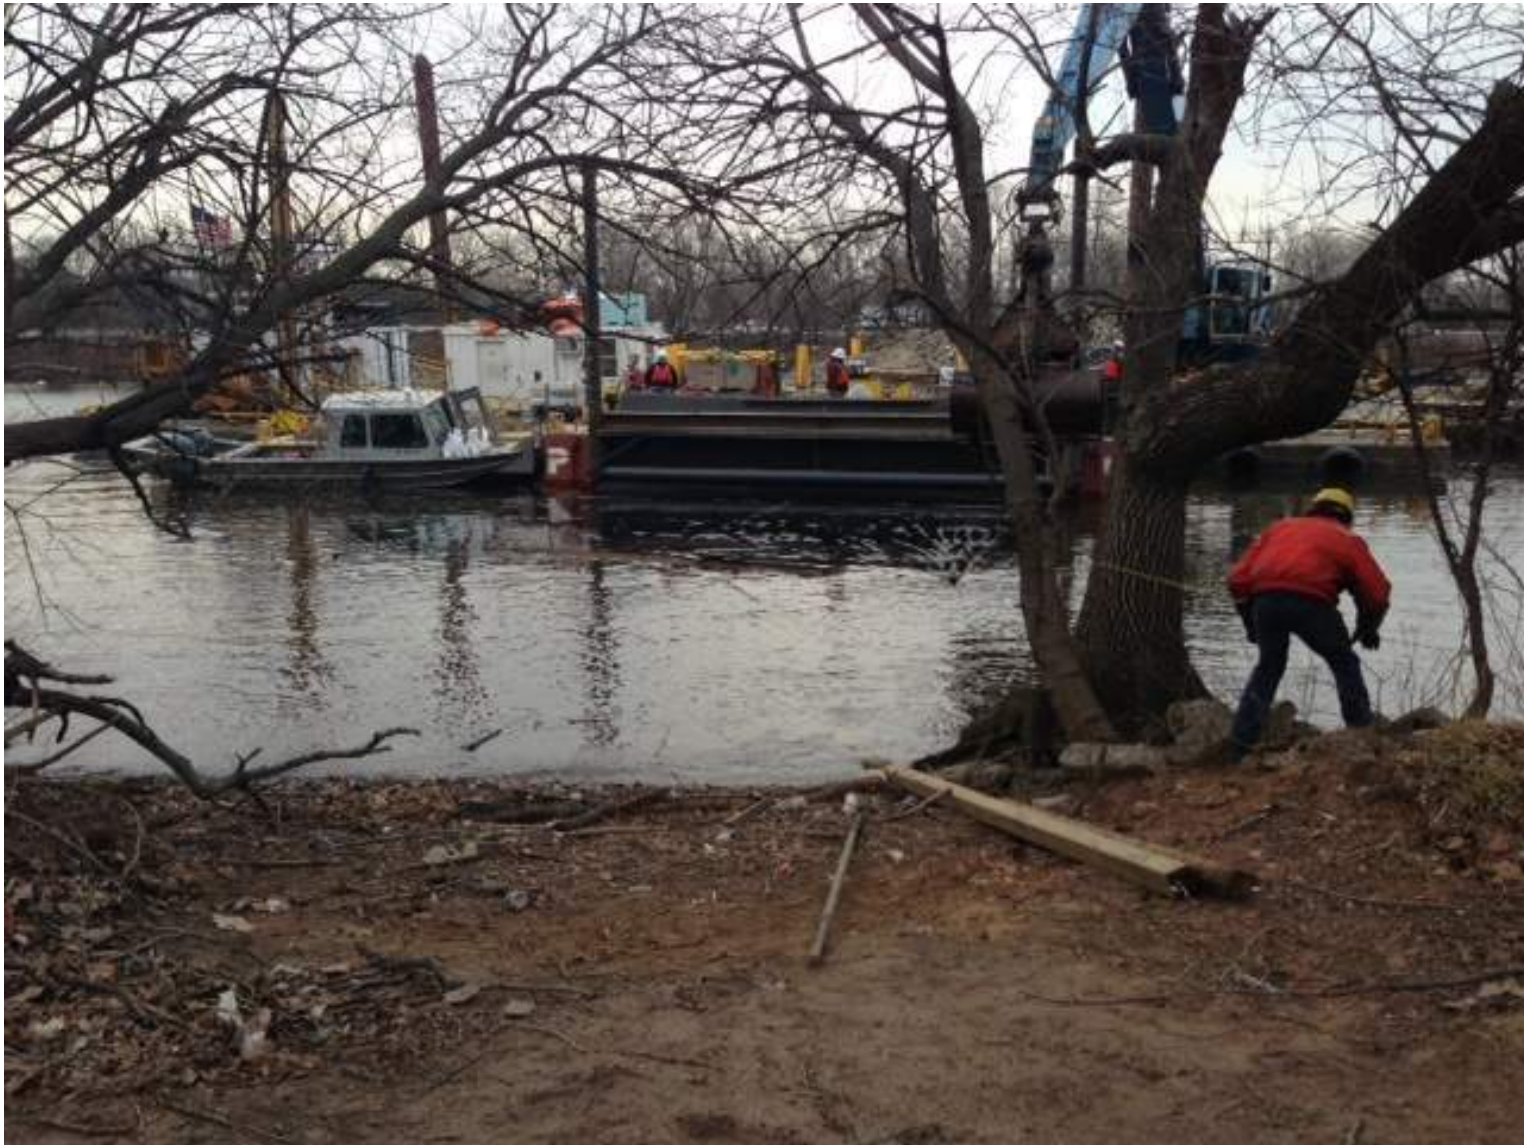
Panel 2-N Installation

Geotextile panel 2-N was installed at high tide between 1720 and 1850. Beginning tomorrow, Friday, March 28th, GLDD will transition to the morning high tide instead of the evening.

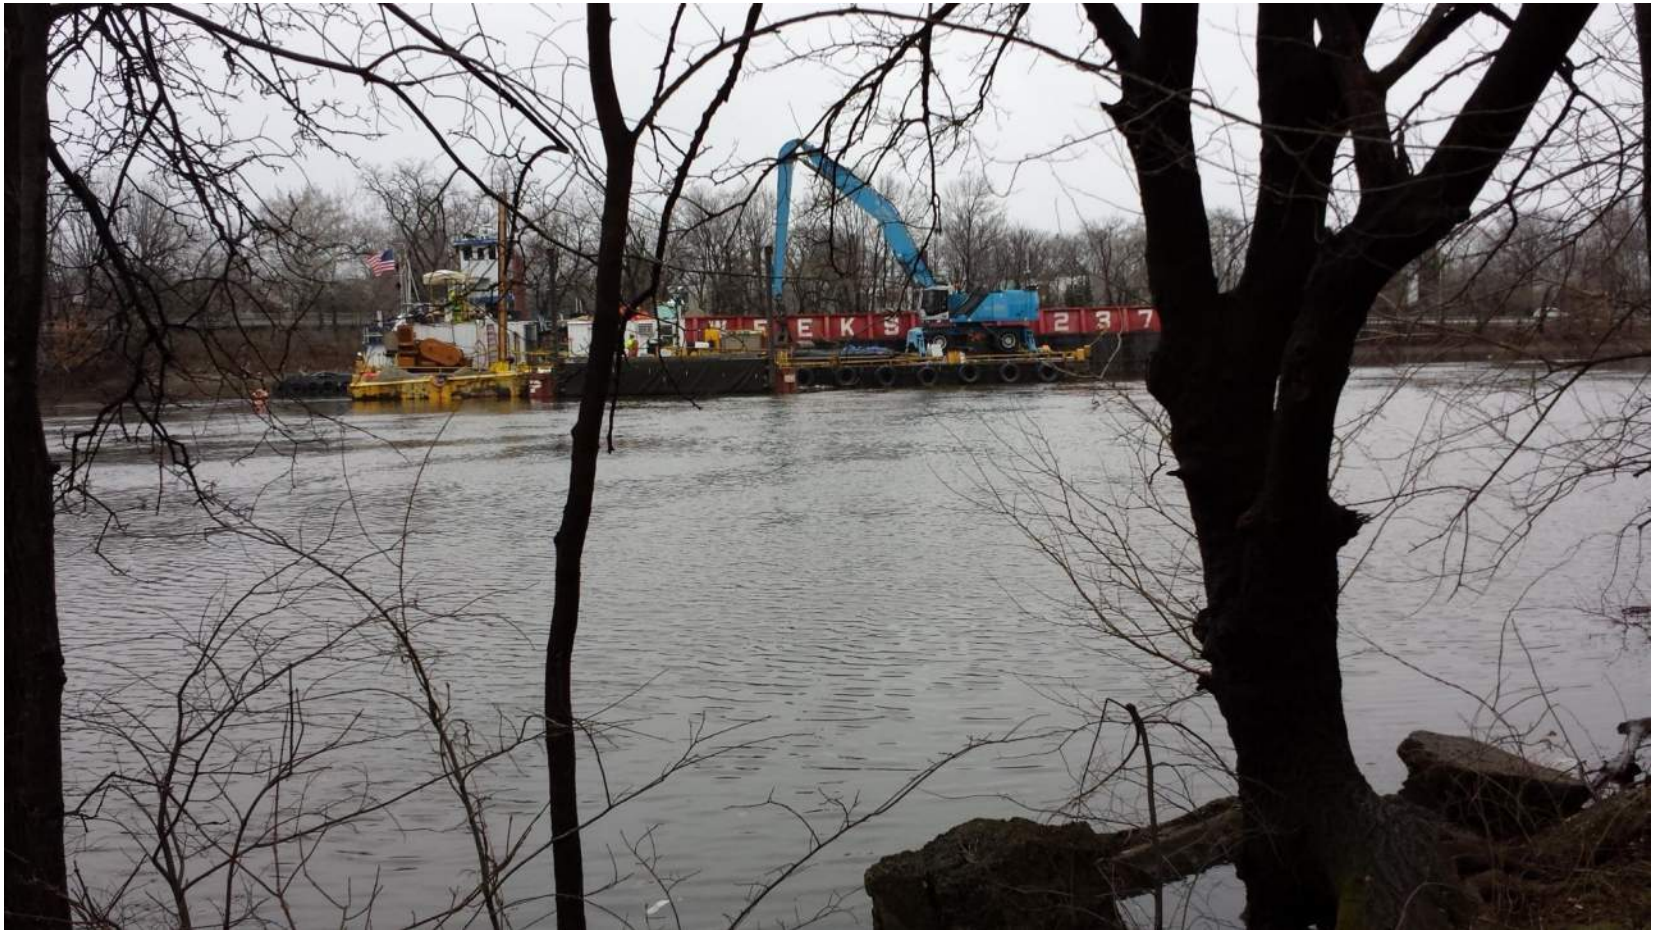
Onsite Set Up

Taken at 12:00 pm, no onsite activity taking place.

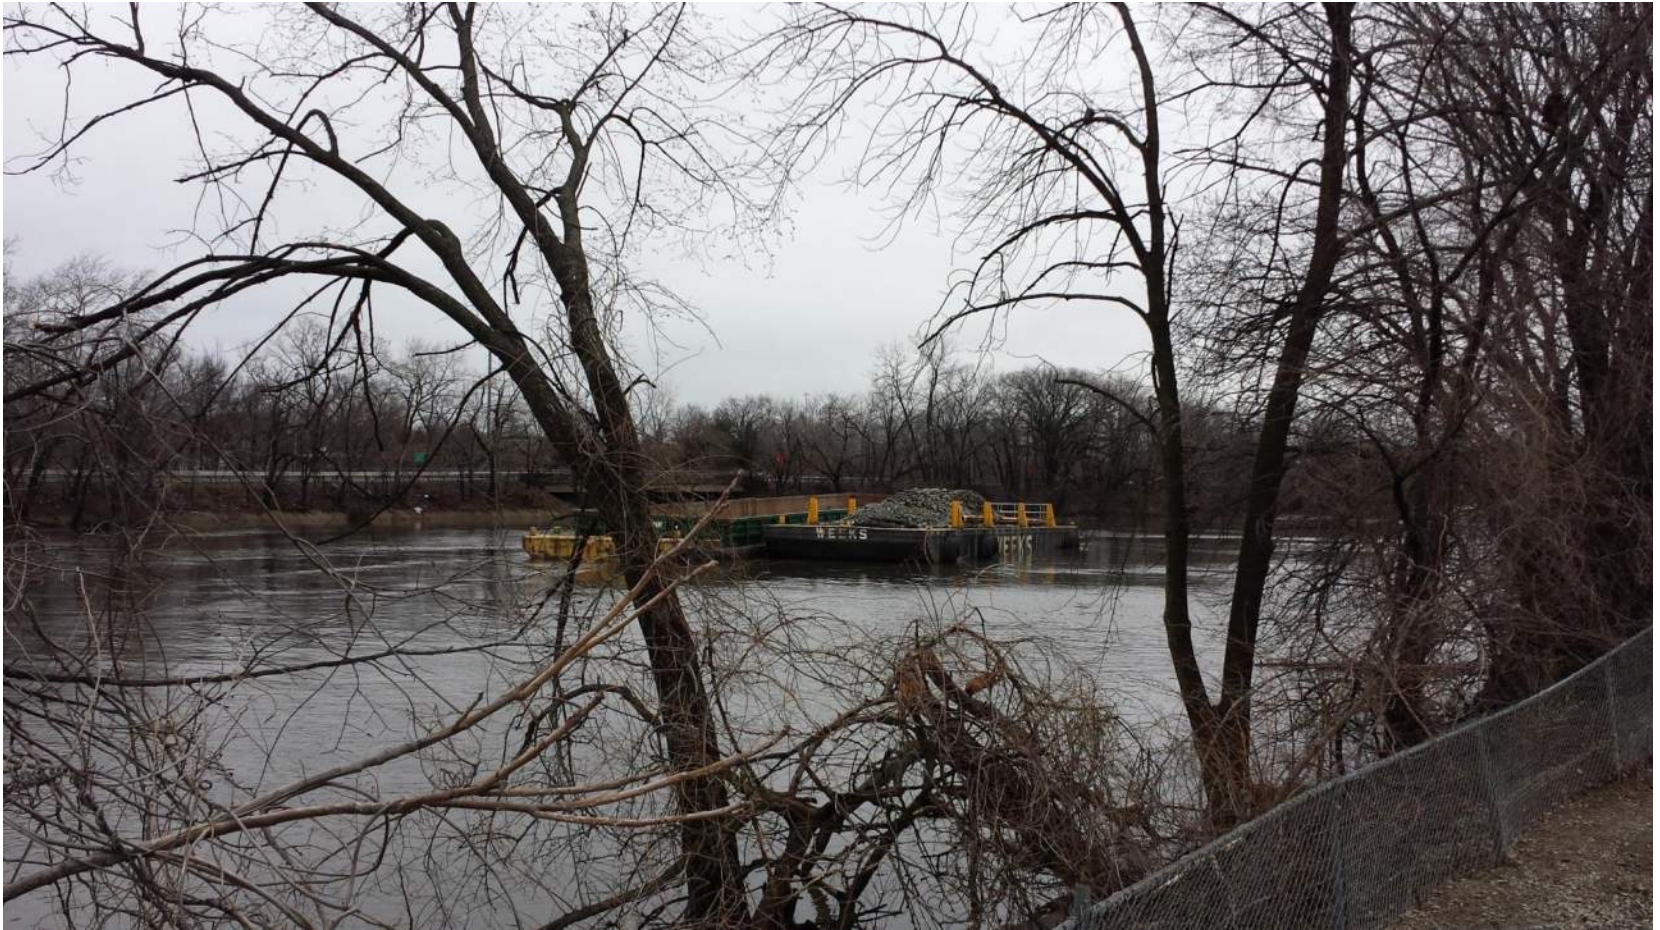
Onsite Set Up

Stone is staged up near northern panels past the pump station.

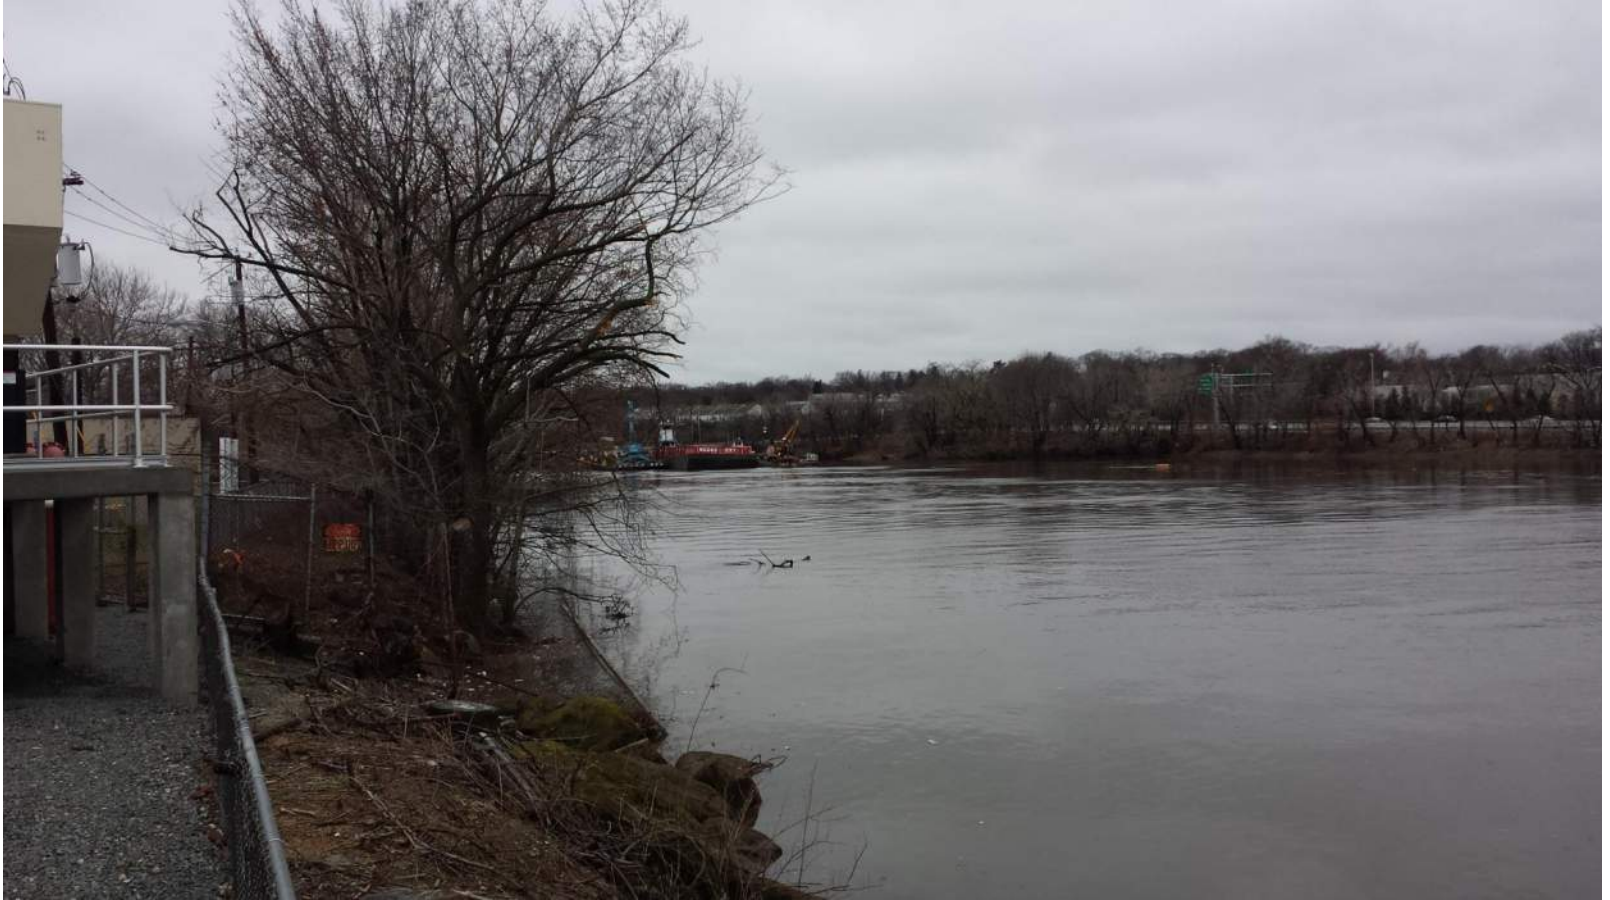
Onsite Set Up

Crews are still located closer to most recently laid panels, adjacent to the park.

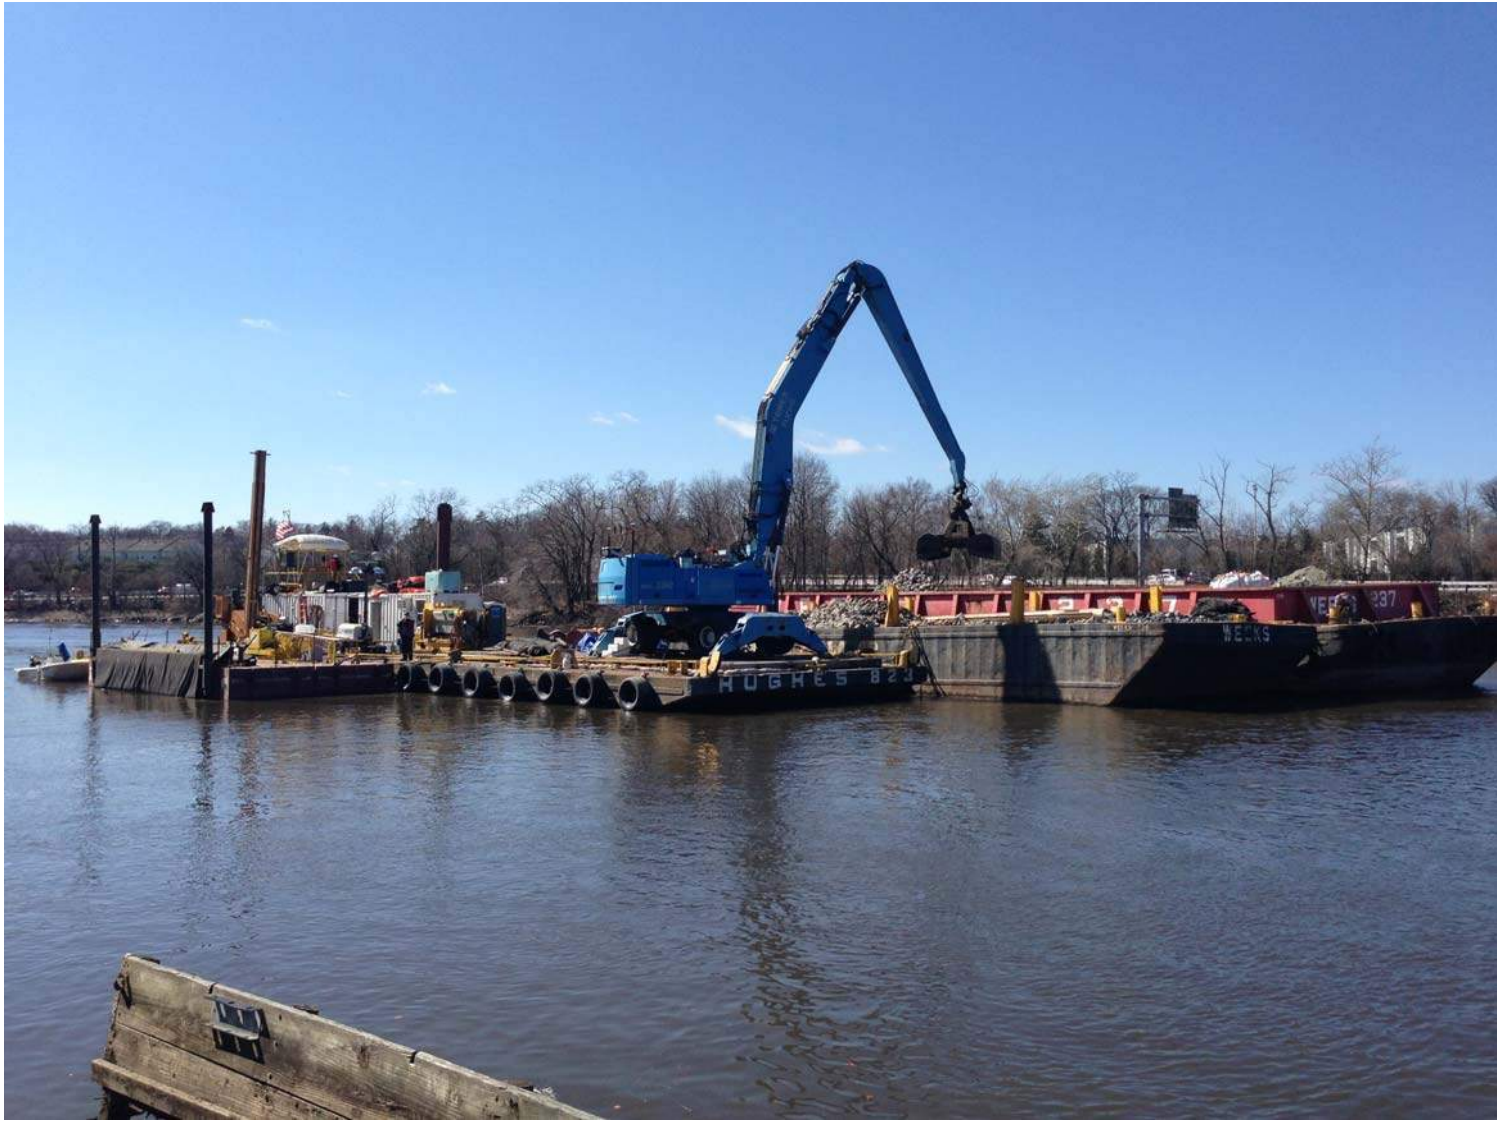
Armor Stone Installation North of NDZ

Most of the day was spent adding armor stone to the areas north of the No Dredge Zone where geotextile fabric and armor stone have been installed but where GLDD's surveys showed insufficient armor stone thickness.

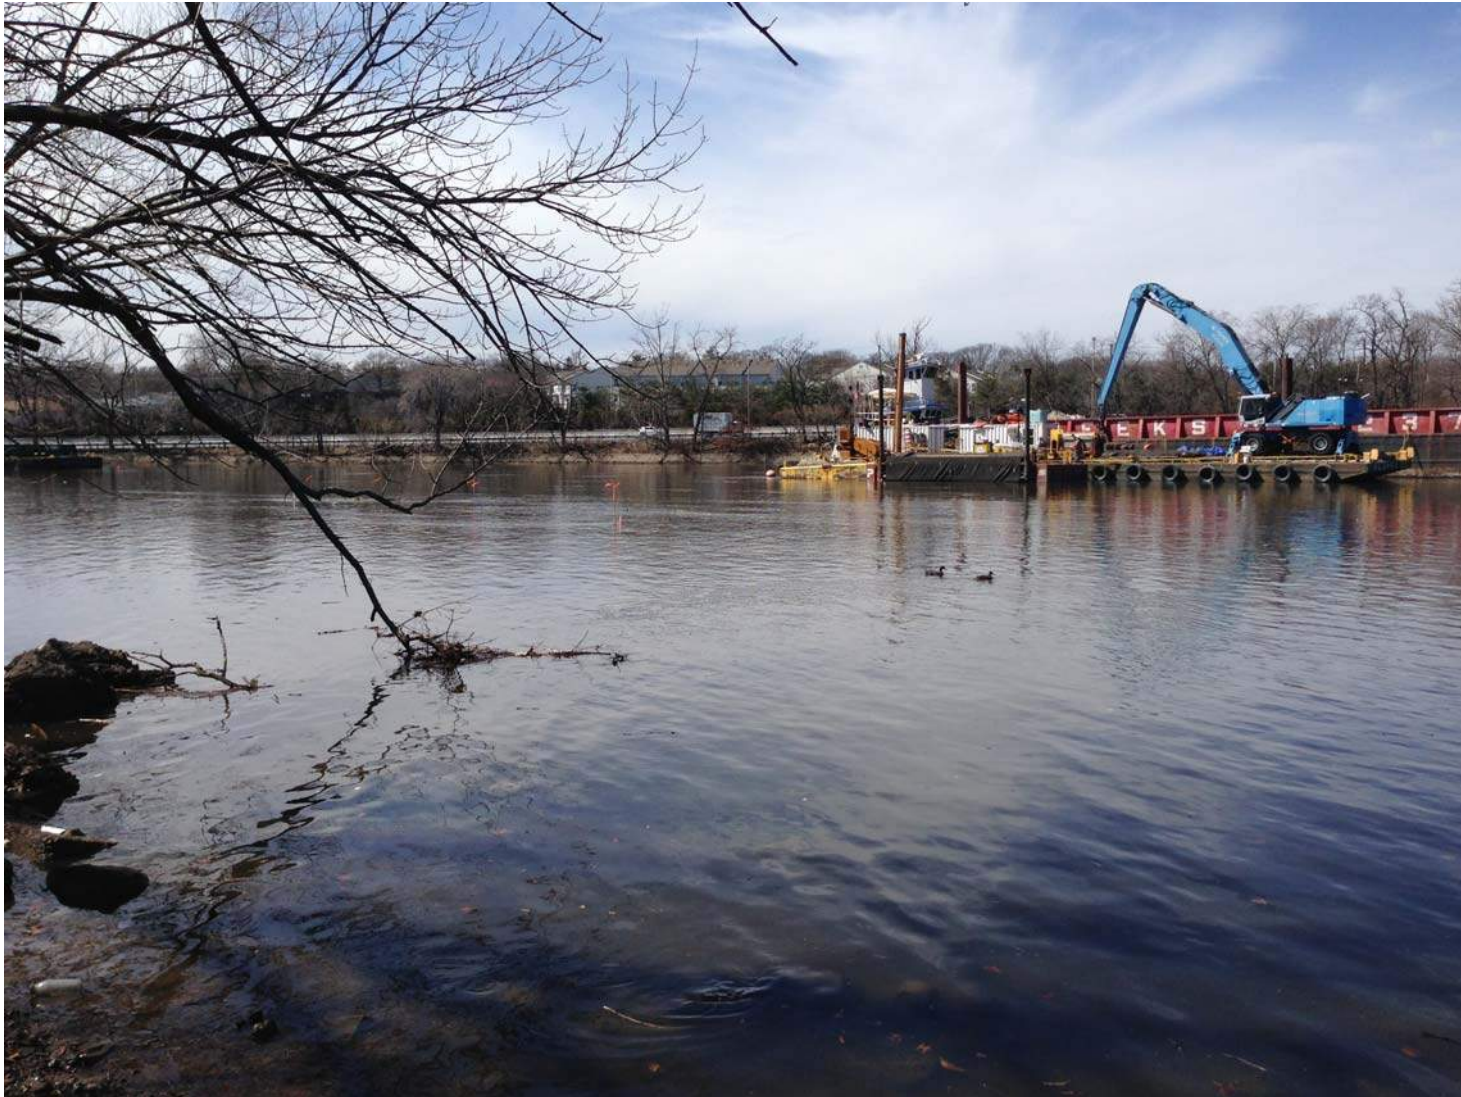
Armor Stone Raking Locations

In the course of surveying the capping area today, GLDD marked out the locations where some armor stone needs to be removed before geotextile installation can proceed. Armor stone removal, though originally planned for today, will in fact take place tomorrow morning.

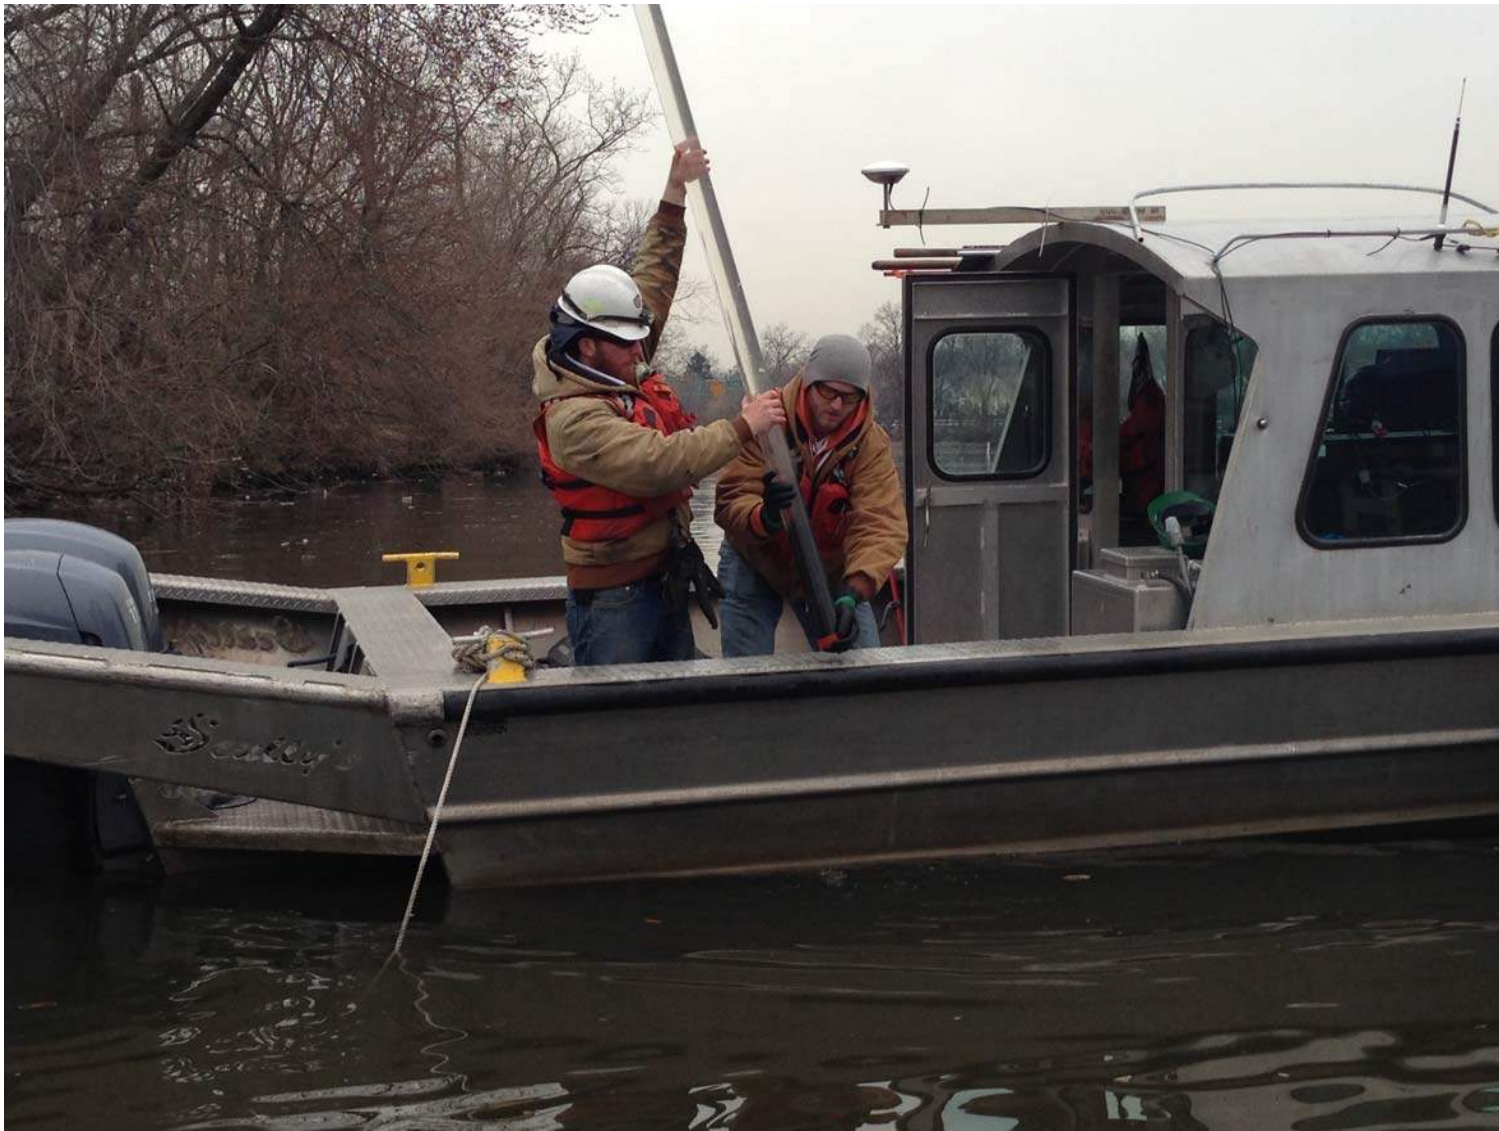
Active Layer Thickness Coring

GLDD collected two cores in the area south of the No Dredge Zone where armor stone removal was performed today. The active layer thickness measured 8.5 inches in one core and 9.1 inches in the other core. Supplemental sand and AquaGate were then applied to this area.

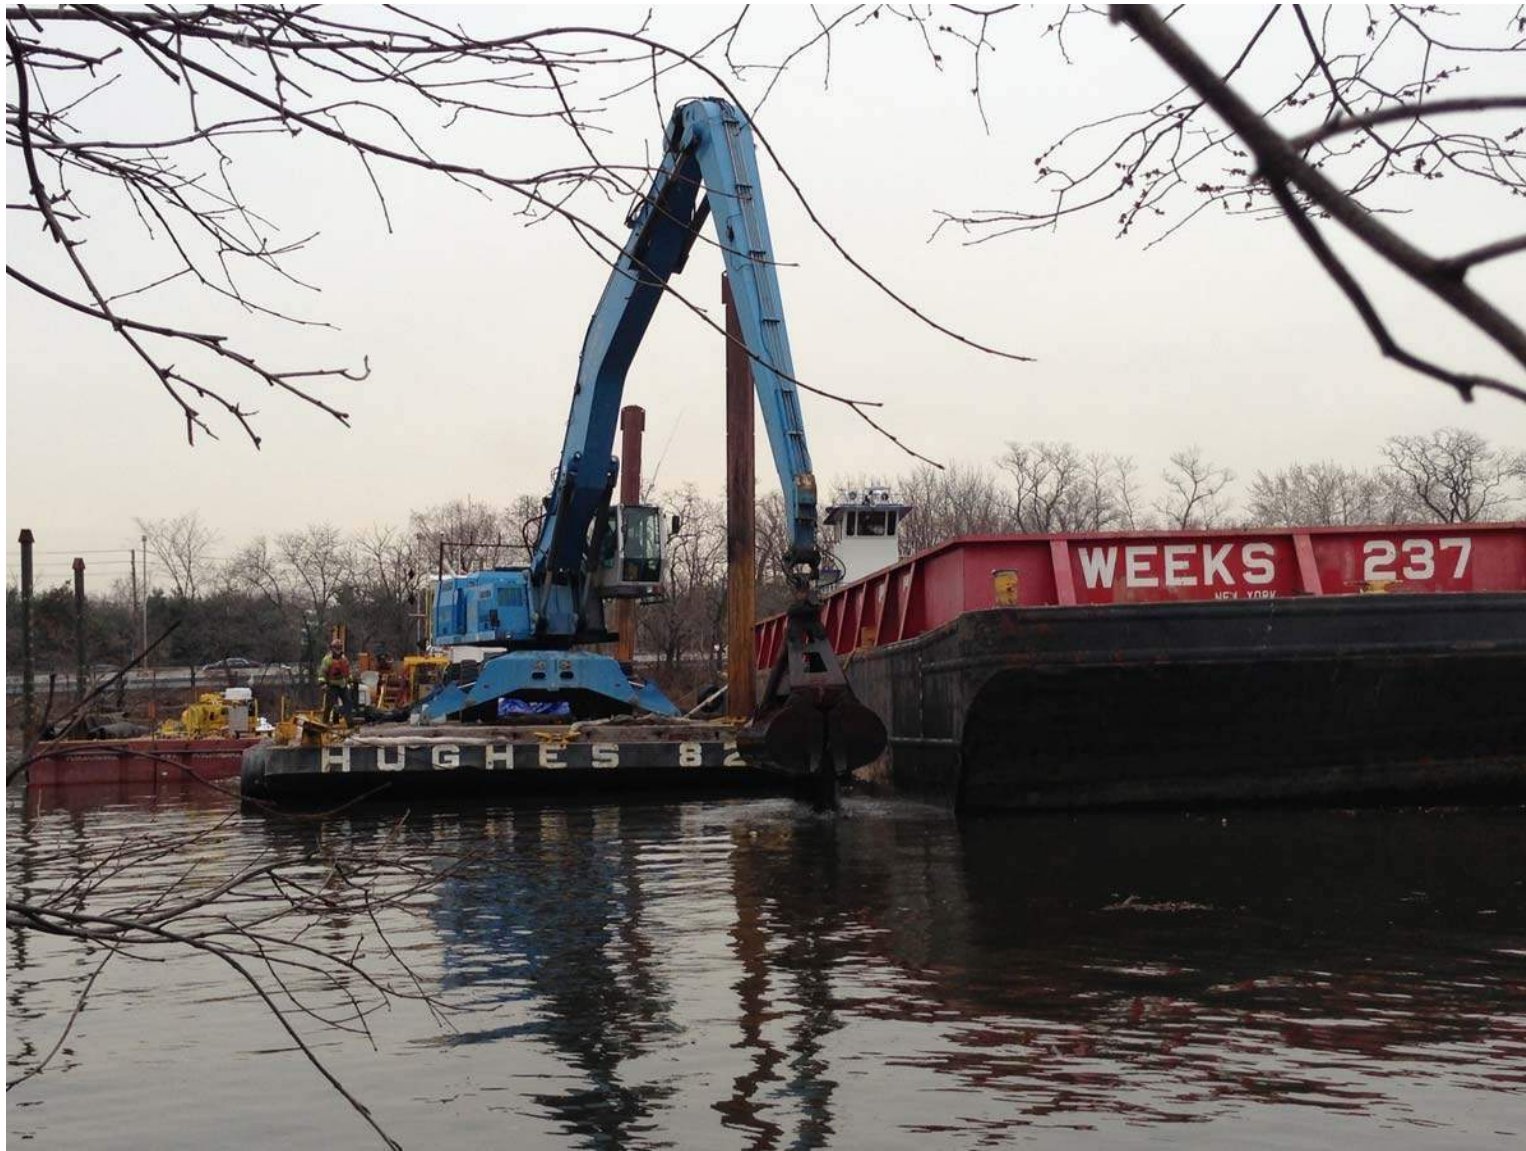
Supplemental Active Layer Placement

Using the Fuchs excavator bucket, a mixture of sand and AquaGate was applied to the disturbed area. The application was performed steadily for an hour.

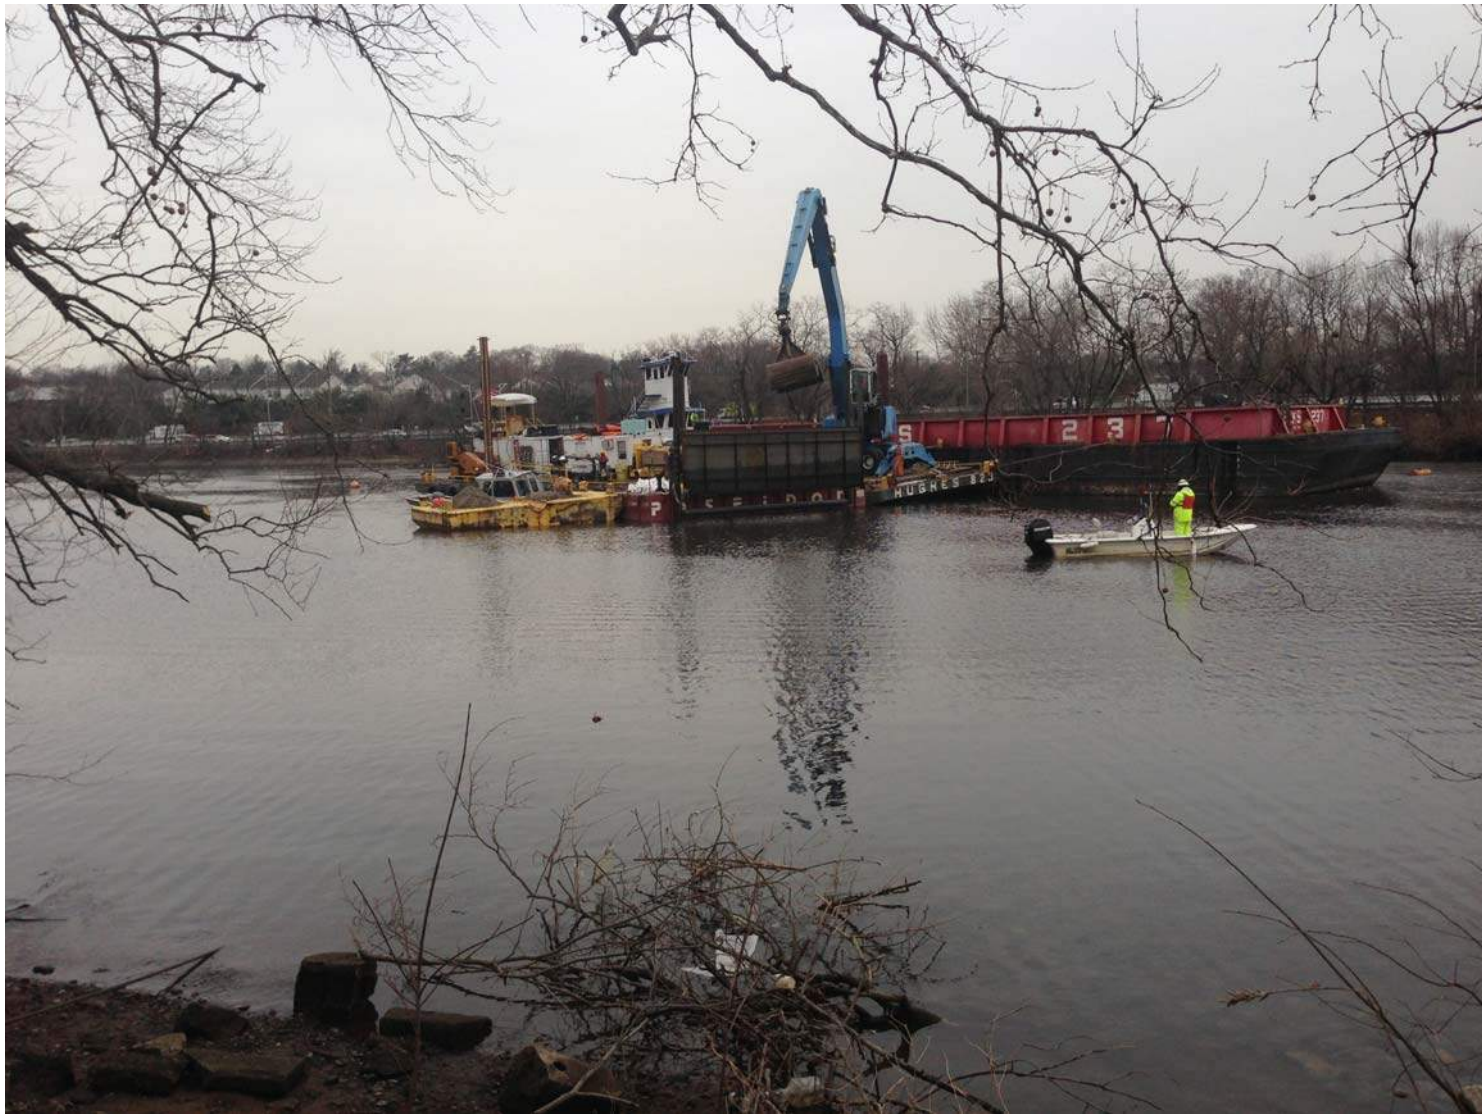
Fabric Chute

Early in the day GLDD lifted the fabric chute out of the Weeks barge (red, shown above), where it is being manufactured, and held it up to the Poseidon barge to verify the sizing. There is still another day of welding required before the fabric chute is completely built.
